STATE OF NEW YORK
MARIO M. CUOMO, Governor

DEPARTMENT OF TRANSPORTATION
JAMES L. LARocca, Commissioner

TECHNICAL REPORT 83-5

**PERFORMANCE OF LATEX MODIFIED AND
HIGH DENSITY CONCRETE OVERLAYS**

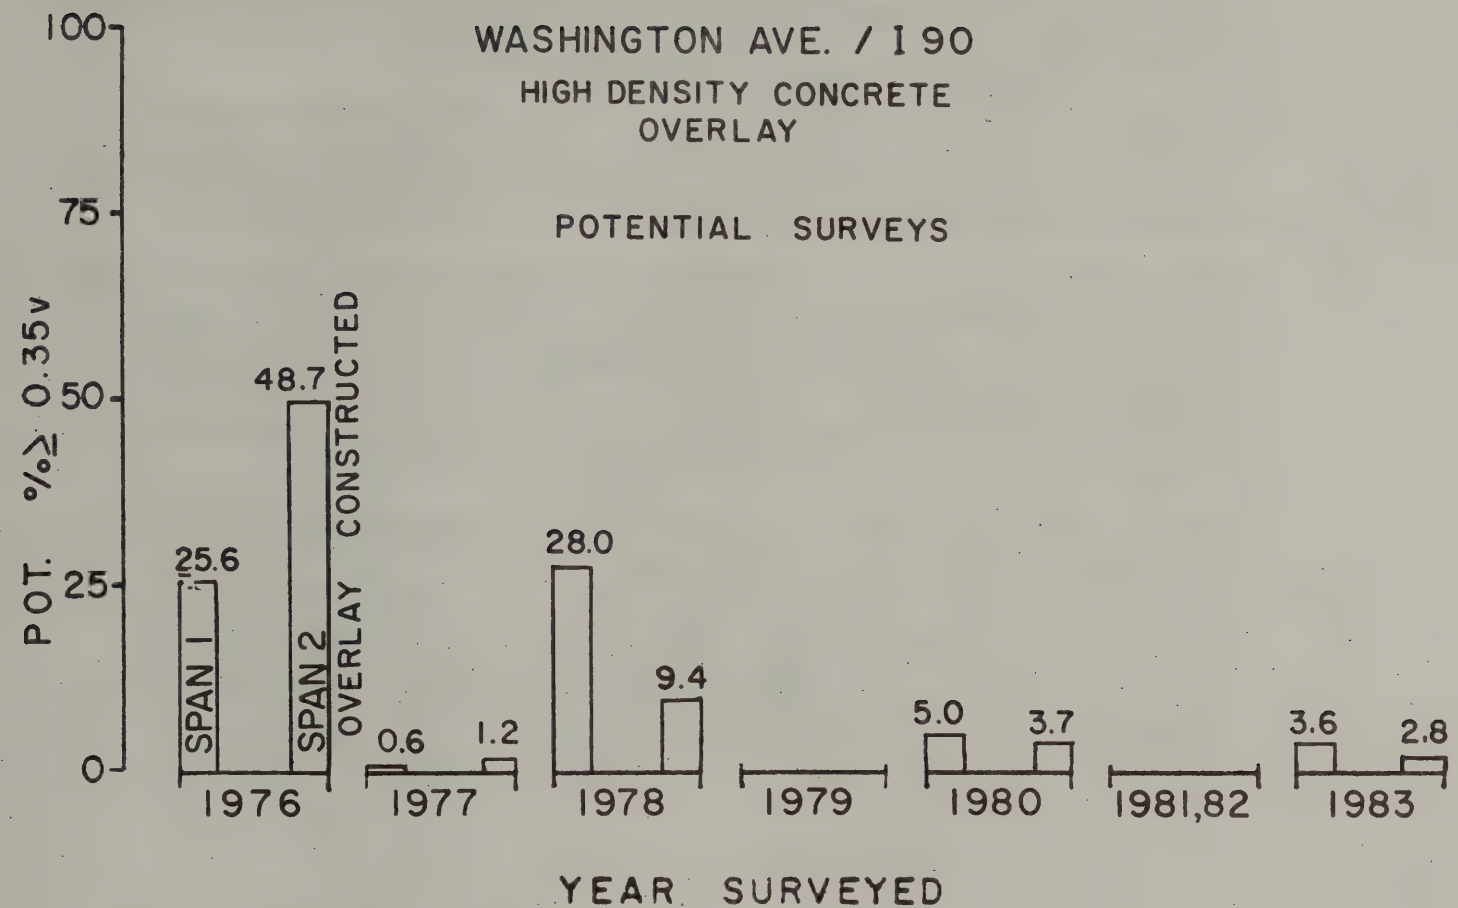
FIGURE 1

Figure 1 shows the initial high percentage of active corrosion before construction and the low percentage of active corrosion after construction of the overlay in 1977. In 1978 active corrosion increased in span 1 and 2 adjacent to the longitudinal construction joint between overlay placements. This butt joint had separated and moisture, oxygen and deicing chemicals had penetrated causing active corrosion to occur. The potential survey in 1978 also showed a general area of active corrosion in one lane. This is partially explained by the presence of radial cracking emanating from core holes. Cores had been taken to determine bond strength. It appears that cracking was due to normal shrinkage which initiated at the core hole when the coring broke the uniformity of the overlay. Though the core holes had been patched, moisture, oxygen and deicing chemicals did penetrate to cause active corrosion. Some areas around core holes had delaminated.

Narrow width transverse cracking was also present in this overlay and potential readings indicating active corrosion were associated with them. No hollow sounding delaminated areas were found in the vicinity of the transverse cracks or at the separated longitudinal joint.

In 1980, active corrosion had become very low and survey data showed active corrosion had occurred at some patched areas (not all radial cracks were removed). Active corrosion was also occurring in some areas at the longitudinal construction joint.

In 1983, active corrosion continued to be very low, and was associated with cracks. No delaminations were found in the overlay. However, three out of the four patched core holes had delaminated. One of these had spalled due a thin edge of the patch material.

Maintenance forces corrected the minor spalling at the core hole and the delamination by chipping out the delaminated area and using a quick setting concrete repair material.

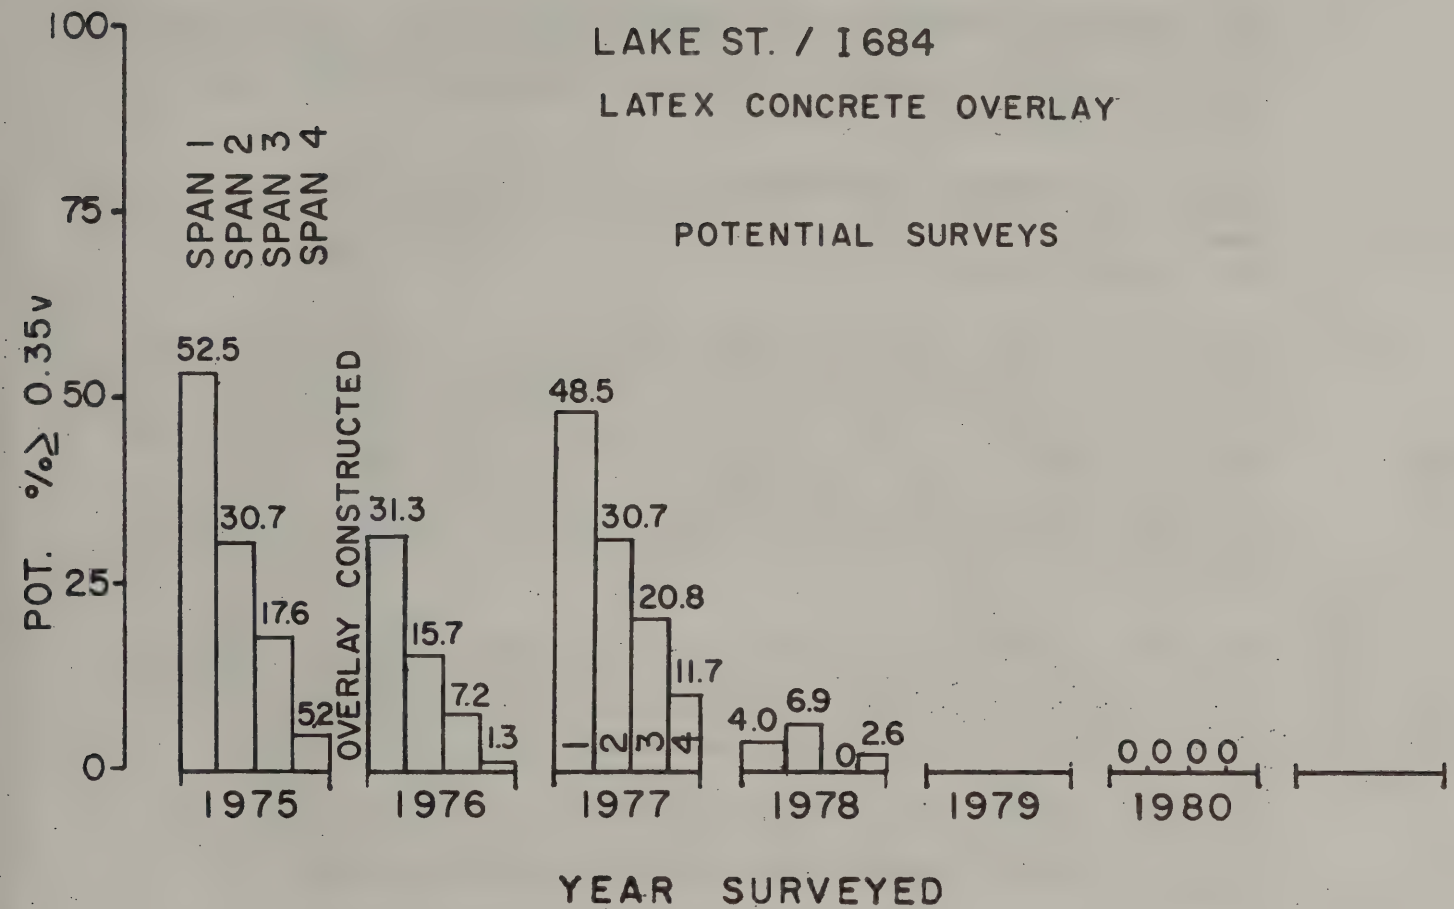
FIGURE 2

In Figure 2 the percentage of potential values greater than 0.35v are plotted for each span of this structure. The 1975 data shows the initial high values of active corrosion associated with the reinforcing steel and associated concrete spalling in the original concrete deck.

After overlay construction, potentials were again surveyed. The data showed a decrease in percentage of active corrosion, but still significant amounts in spans 1 and 2. Another survey in 1977 showed an increase in active corrosion in all spans but a delamination survey done using a chain drag revealed no delaminations. Subsequent potential surveys in 1978 and 1980 showed active corrosion had dropped to low values and then to nothing. Surveys performed in 1978 and 1980 showed no delaminations.

Moisture and oxygen sealed in the deck by the impermeable overlay may be responsible for the initial high values of active corrosion noted in 1976 and 1977. It appears that active corrosion later ceased due to moisture in the deck evaporating, probably through the deck underside. Based on the potential data and delamination surveys, some corrosion did occur after construction, but was not severe enough to cause expansive corrosion and delamination and eventual spalling of the overlaid deck.

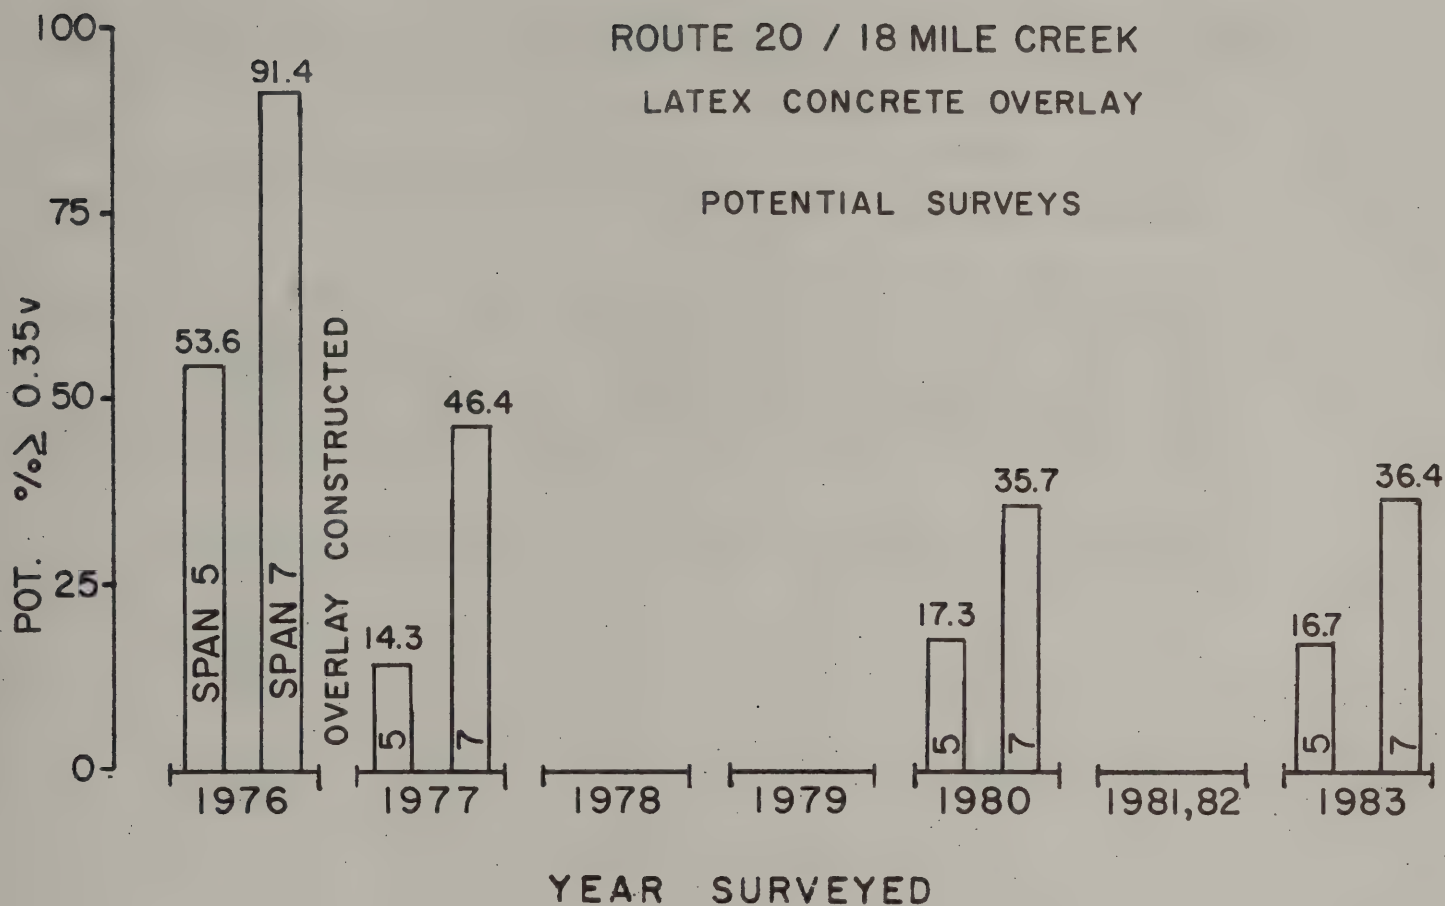
FIGURE 3

Potential, visual and delamination surveys were conducted before and at intervals after construction. The results of the potential surveys are shown in Figure 3. Extensive areas of active corrosion existed in spans 5 and 7 before construction.

A potential survey, six months after completion of construction, showed a decrease in active corrosion. Visual observations and delamination surveys at this time showed the longitudinal construction joint had separated. This is the same style butt type joint which had separated on other structures. Some short, 6 to 18 inch long cracks, were noted perpendicular to the longitudinal construction joint and at the transverse joints. Some wider longitudinal and transverse cracks were seen in the middle of some spans. Many transverse joints have hollow sounding delaminated areas on each side of the joint.

The "wider" cracks in the overlay are due to existing cracks reflecting through the overlay. The short length tight cracks may be due to excess water in the latex concrete mixture which showed up as shrinkage cracks. The separation and cracks will be observed for their future effect.

The hollow sounding areas indicate delaminated areas of the overlay and since they occurred so soon after construction appear to be related to surface preparation and bond rather than environment and material performance.

In 1980 and 1983, potential surveys showed similar percentages of active corrosion as those seen after construction in 1977. The same areas of the west lane, in span 5, that showed active corrosion in 1977 also show active corrosion in 1980.

In span 7, the active corrosion areas of 1977 and 1980 coincide near the north joint. Other areas of span 7 no longer show active corrosion.

The areas of greatest concern are spalled areas which have occurred at the north joints of both spans. These areas coincide with areas of active corrosion and the hollow areas found in 1977.

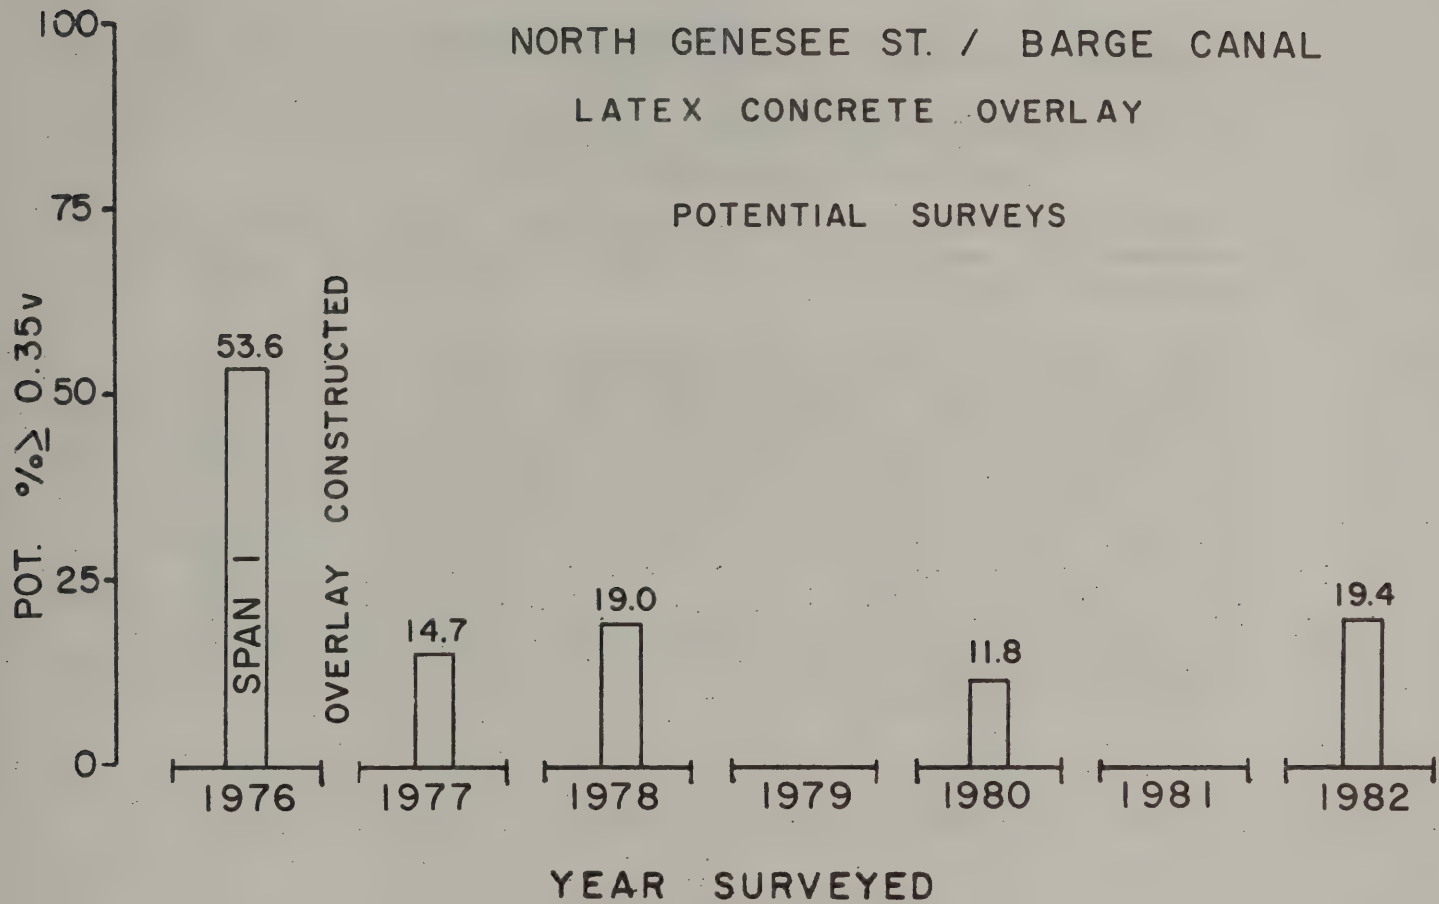
FIGURE 4

High percentages of active corrosion existed before concrete removal, surface preparation, and overlay placement. After construction it was found that areas of active corrosion decreased. It was observed that the longitudinal construction joints had separated after construction. This is similar to the separation of other "butt" type joints. Some of the areas of active corrosion are associated with leakage at this separated joint. Other areas of active corrosion are near the transverse joints.

No cracks, delaminations or spalls were noted in this Latex Modified Concrete overlay in the 1982 survey.

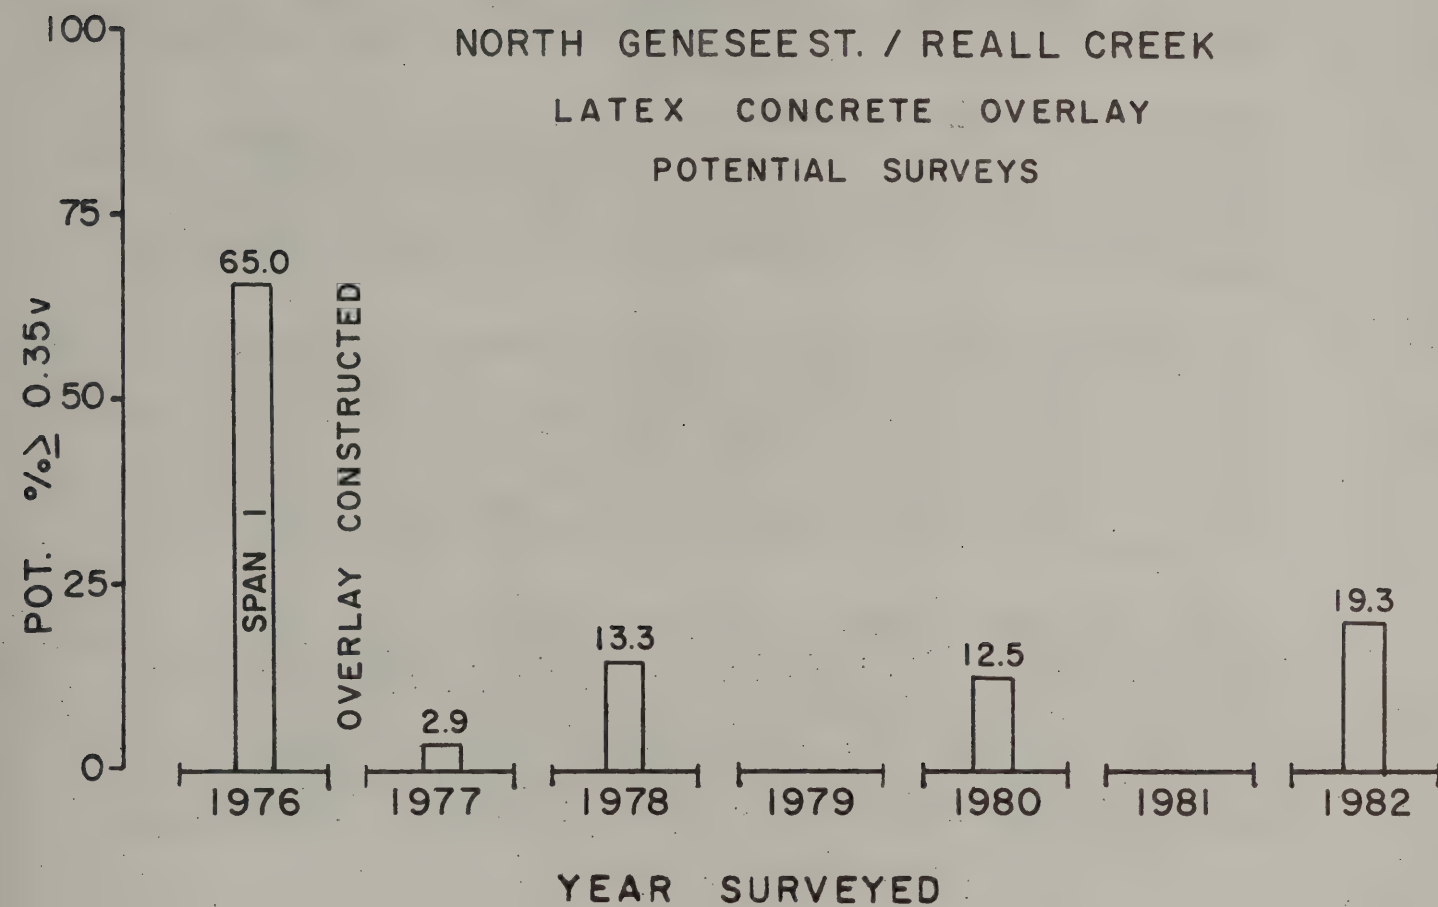
FIGURE 5

Figure 5 shows the initial high percentage of active corrosion before construction in 1976 and the low percentage of active corrosion after construction in 1977. In 1978 corrosion potentials increased. A few cracks were observed in the northbound area of the deck. In 1980 the cracks in the northbound driving lane were hairline and confined to the extreme east end. By the 1982 potential survey, the cracks had become more pronounced and the delamination survey showed that the area near the cracks were debonded. Cores were taken to determine the extent of the delaminated concrete. The cores demonstrated that the overlay had not debonded but that not enough of the original concrete had been removed and corrosion of the resteel had progressed until that area of the bridge deck concrete cracked and debonded from the reinforcing steel.

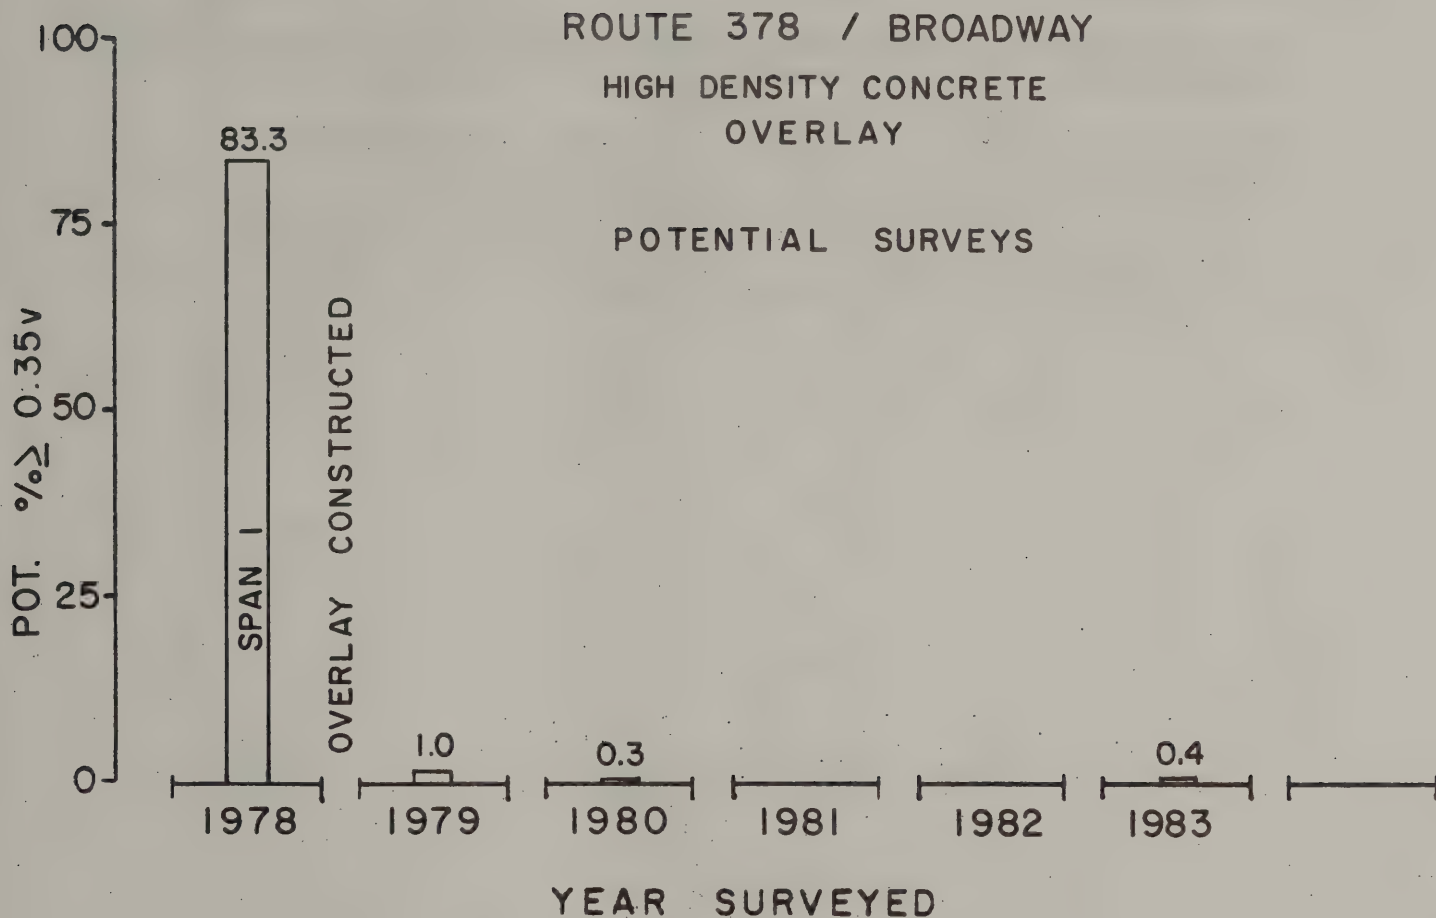
FIGURE 6

Potential values greater than 0.35v were found before construction in the majority of the deck area. Potential data is presented in Figure 6. Due to the spalling and large area of active corrosion, the entire surface was removed and concrete excavated to one inch under the top rebar mat. This resulted in the top rebar mat being encased and covered with high density concrete.

Potential data taken in 1980 and 1983 shows only 0.3 percent and 0.4 percent of the readings respectively are greater than 0.35v. This is due to one potential reading in each survey which occurred near an armored transverse joint. This reading is suspect, since it probably is measuring corrosion of the steel armor angle rather than the top rebar mat. The 1980 and 1983 data shows that no areas of active corrosion exist over the deck area including the longitudinal construction joint. No hollow areas were found during the delamination survey.

The longitudinal construction joint between placements was constructed differently than the butt joint used previously. The edge of the new overlay is sawcut $3/4 \pm 1/8$ inch deep longitudinally, the remaining depth of overlay is chipped to form a 45 degree bevel. Mortar grout is applied before the adjacent overlay is placed. The additional surface area due to the chipping and beveling has provided a water tight joint that does not separate. The "beveled" type construction joint was specified in this and for future projects.

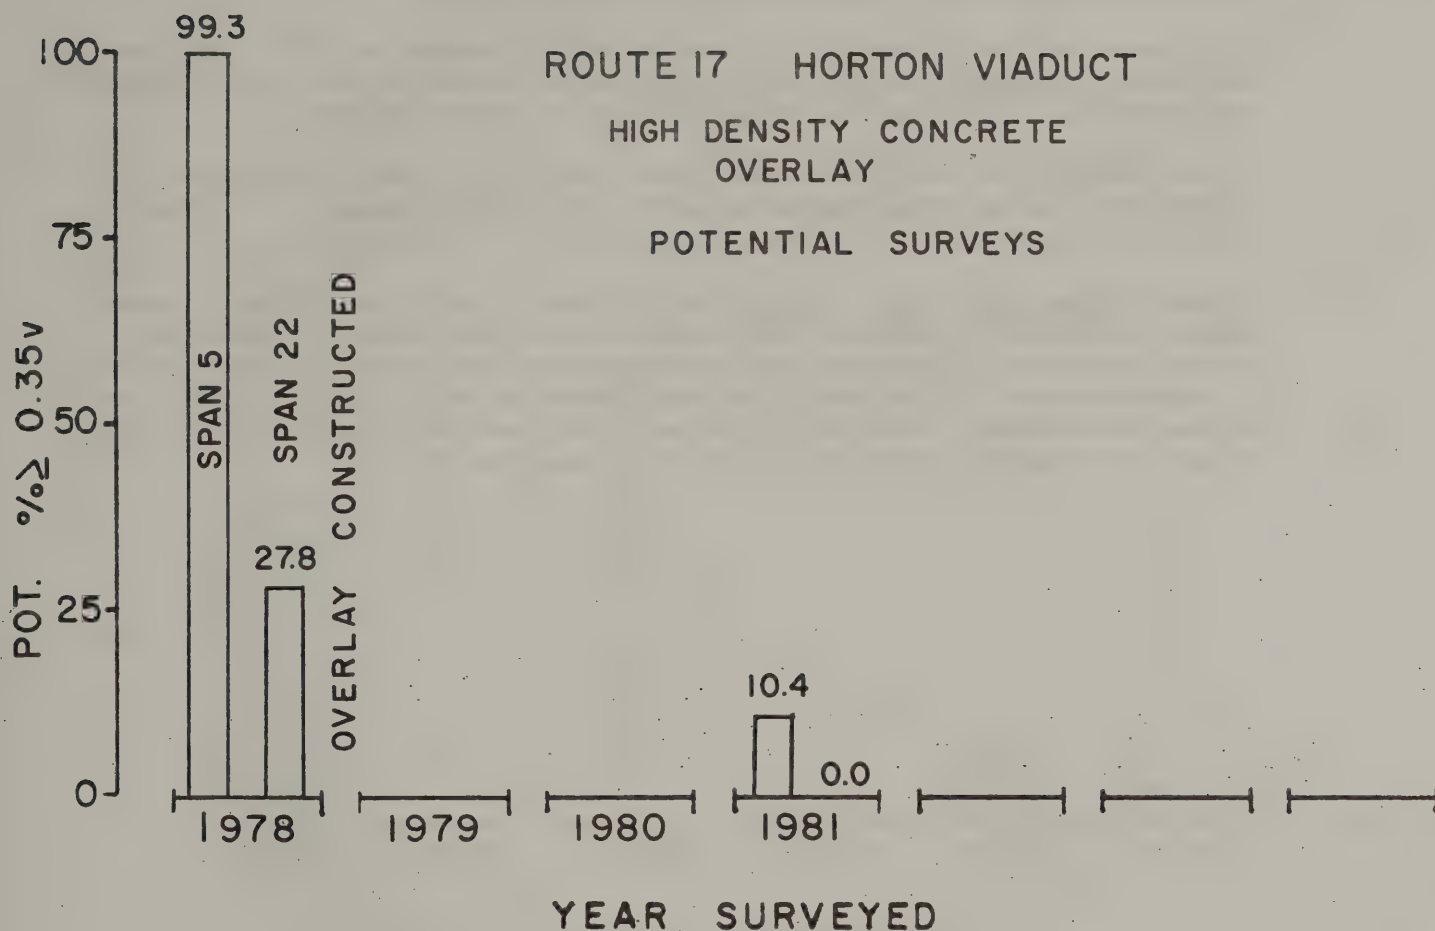
FIGURE 7

Potential, delamination and visual surveys were conducted before construction and in October 1981 and are presented in Figure 7. Span 5 in 1981 exhibited no surface defects while span 22 showed only surface mapcracking. Figure 7 shows the high percentage of corrosion before construction of the High Density Concrete overlay in 1978-79 and the very low percentage of active corrosion in 1981.

*Note: 70% of span 22 was overlaid with asphalt concrete due to spalling deterioration, potential measurements were only possible on the uncovered concrete deck.

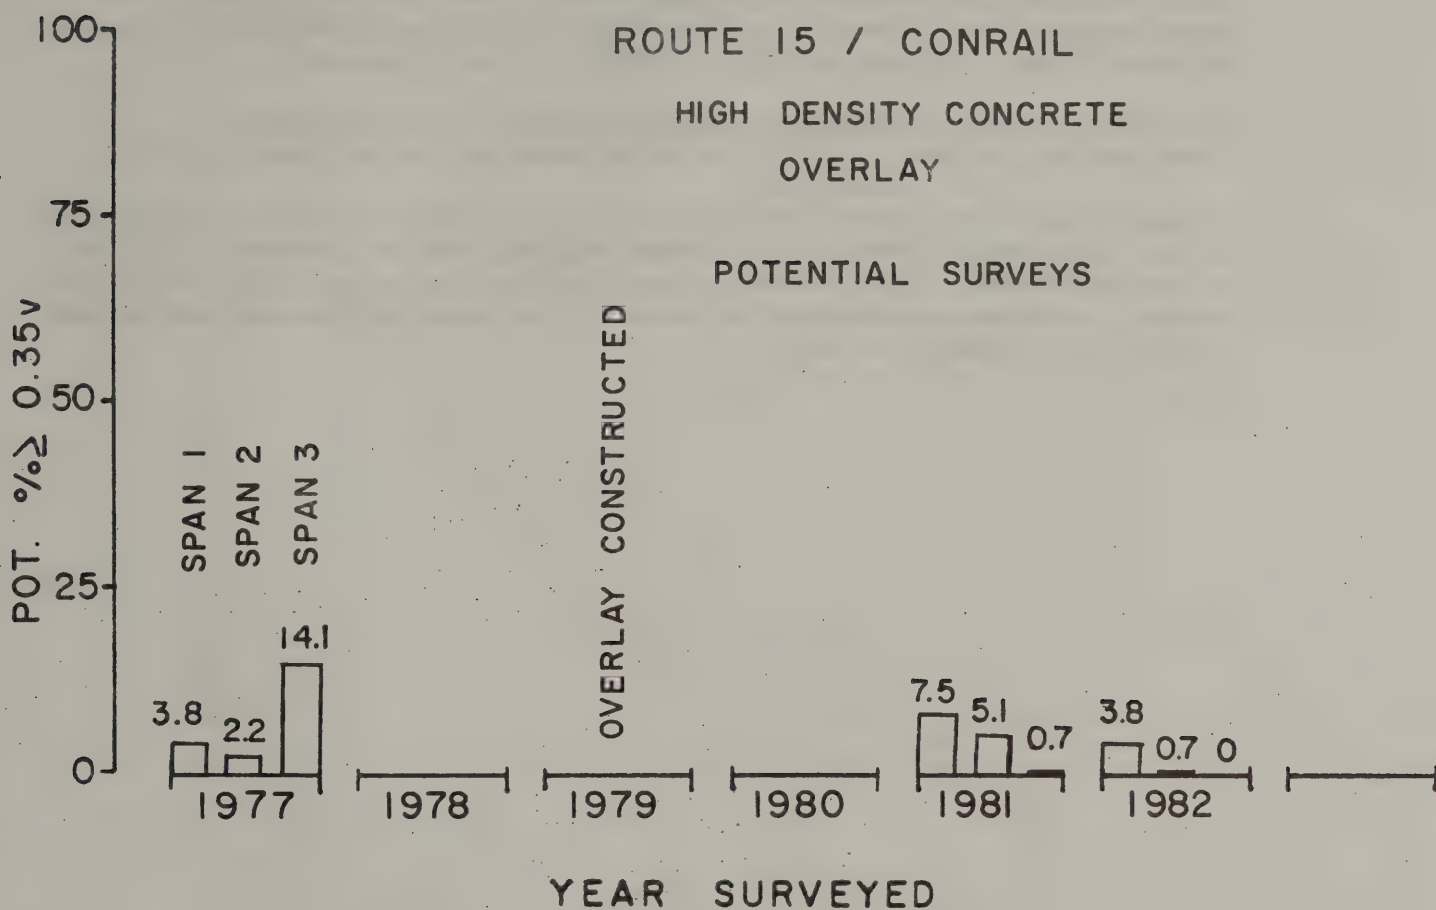
FIGURE 8

Figure 8 shows the initial low values in spans 1 and 2 and higher in span 3. During construction concrete was removed around the resteel in areas of active corrosion. These deep concrete removal areas were the least in span 1, approximately 30% in span 2 and approximately 50% in span 3. The areas of concrete removal were less in spans 1 and 2 and this may account for the slight increase in corrosion values after construction.

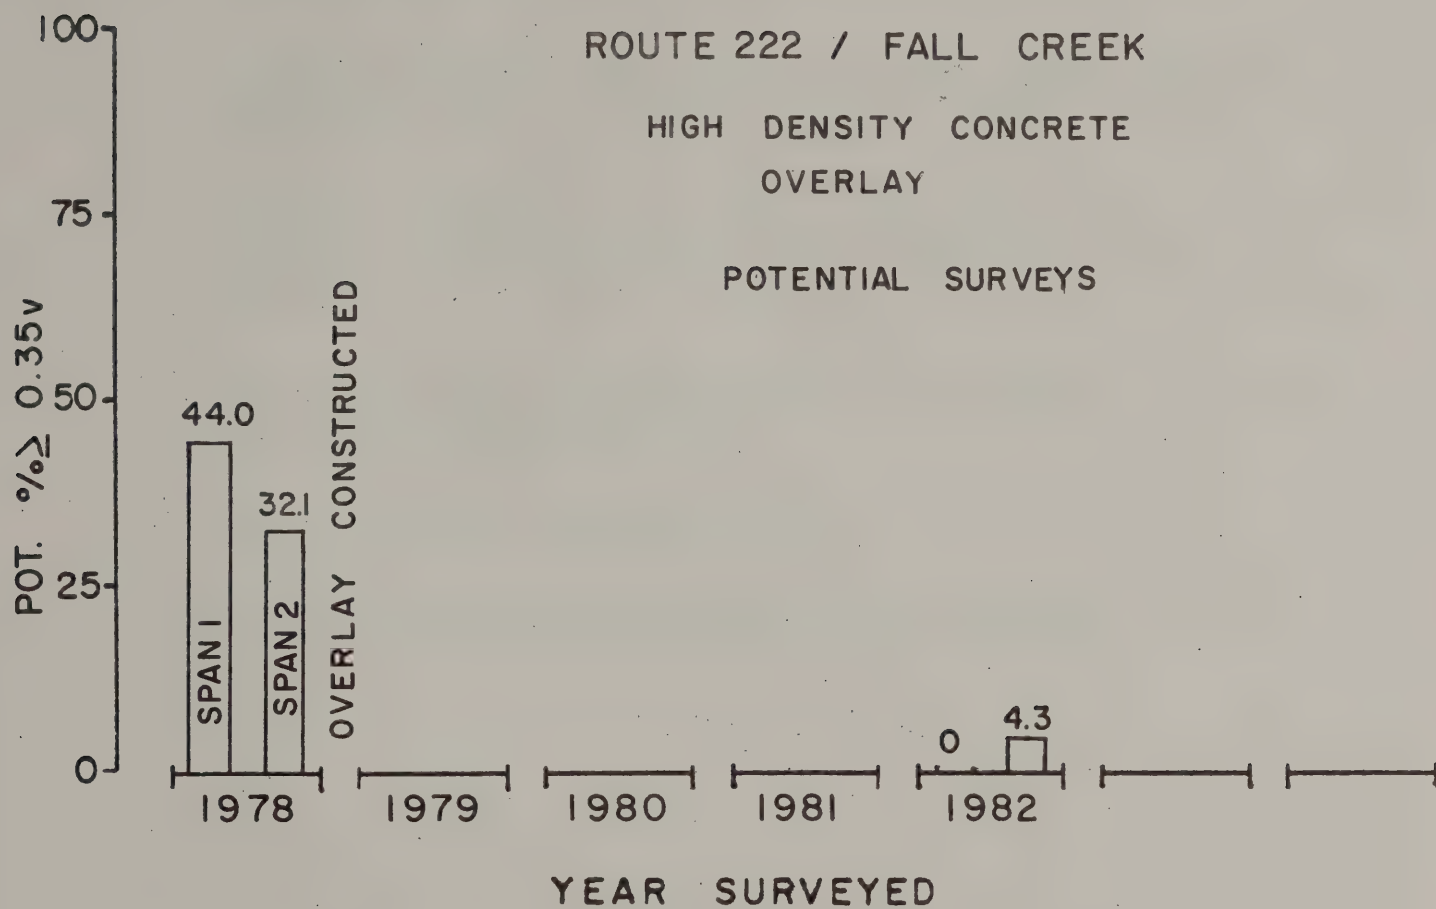
FIGURE 9

Figure 9 shows the initial high percentage of corrosion before construction of the high density overlay in 1979-80 and the very low percent of active corrosion in 1982. Span 1 and 2 show no surface defects in the 1982 survey except a hairline crack where the edge of the existing drainage grates were filled with overlay concrete.
